# SNAPSHOT<sup>®</sup>

EMI SHIELD

## CASE STUDY

## EMI SHIELD RELIABILITY

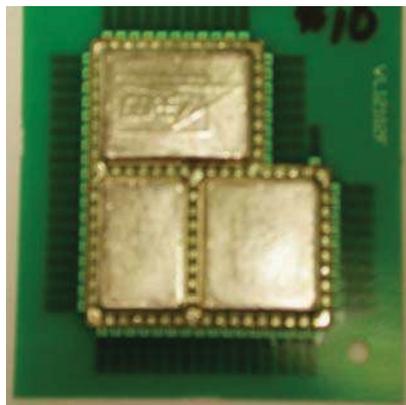
**FIGURE A: INSTALLED TRIPLE CAN**

The test uses a standard configuration known as the “Triple Can” design. The thermoformed Triple Can is installed to a PC board with 87 BGA balls mounted (**Figure A**). The test board is then placed into a fixture, which allows for a 4-point probe DC resistance measurement at each of the 87 contact pads (**Figure B**).

DC resistance was measured before and after mechanical shock, thermal shock, vibration and ALT using the Triple Can Resistance Test. The purpose of this test is to evaluate the electrical contact between the thermoformed part and the standard BGA balls that provide the electrical and mechanical connection.

A Keithly ohm-meter and multiplexer measure and record the resistance from the top of the part, through the BGA ball and to the contact pad. This test simulates the contact between the thermoformed part and the BGA ball and results should be similar to what is to be expected on a final product.

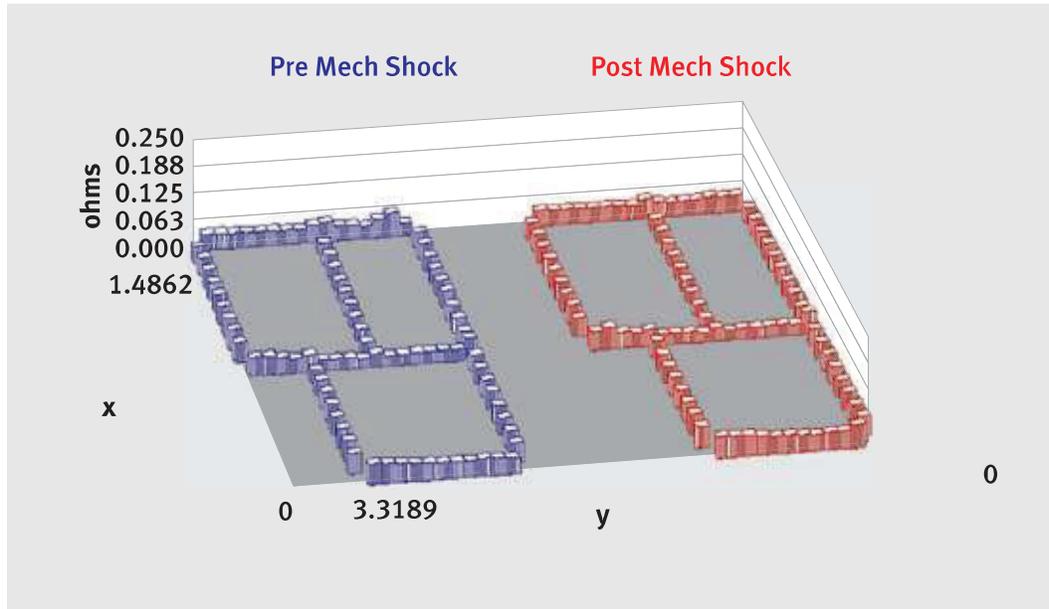
**CHART 1: Triple can average DC resistance before and after Mechanical Shock.**

The DC resistance was measured before and after mechanical shock. Mechanical shock was performed according to JEDEC test method JESD22-B104-B. Each sample was subjected to five shock pulses of the peak (g) level in each of the orientations X1, X2, Y1, Y2, Z1, Z2, for a total of 30 shocks. **Chart 1** and **Table 1** show the average DC resistance results before and after thermal shock. The average was taken from a sample of 6 cans tested. The mechanical shock had little effect on the electrical contact between the BGA balls and the shield. The average DC resistance after impact was 0.036 ohms with a pooled standard deviation of 0.0122 ohms.

Mechanical Shock	
	Pre Stress	Post Stress
Average DC Resistance over all Ball Locations (ohms)	0.0357	0.0362
Pooled Standard Deviation of all Ball Locations (ohms)	0.0121	0.0122

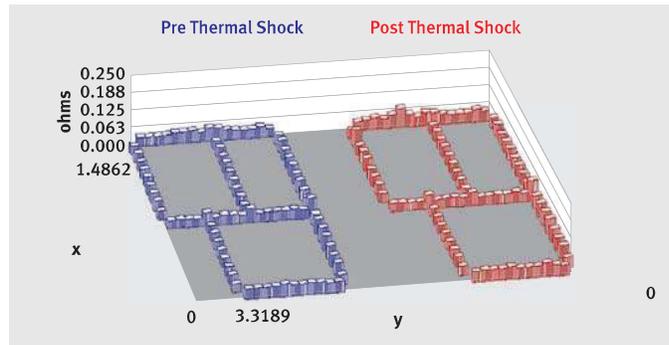
**CHART 2: Triple can average DC resistance before and after Thermal Shock.**

Thermal shock testing was carried out according to the conditions specified in Mil Spec 883 - 1010.7 B for 10 cycles. This method cycles between -55°C and 125°C, holding at each temperature for 10 minutes. DC results before and after shock are shown in **Chart 2** and **Table 2**. All ball locations remained below 0.100 ohms after thermal shock with an average DC resistance of 0.038 ohms. A total of 10 cans were tested as part of this study.

Mechanical Shock	
	Pre Stress	Post Stress
Average DC Resistance over all Ball Locations (ohms)	0.0358	0.0378
Pooled Standard Deviation of all Ball Locations (ohms)	0.0111	0.0197

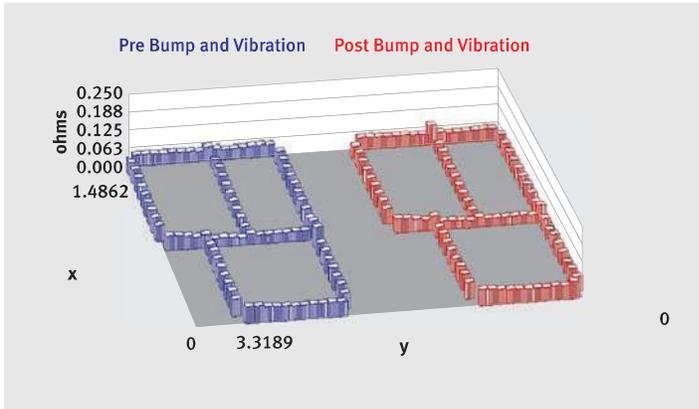
**CHART 3: Triple can average DC resistance before and after Vibration Testing.**

DC resistance was measured on all boards before and after testing. The average results are shown in **Chart 3** and **Table 5**. As seen with earlier results, the DC resistance was insensitive to the bump and vibration stress.

A sample set of 20 triple cans were subjected to bump and vibration conditions according to test standards IEC 68-2-29 and IEC 68-2-64 respectively. Bump and vibration testing occurred in sequence on all boards. The triple cans were bolted to a test plate, which was fixed to a vibration drum. The vibration drum can apply vibration pulses in the X, Y, and Z directions. Details on the bump and vibration test parameters are shown in **Tables 3** and **4** below.

Mechanical Shock	
	Pre Stress	Post Stress
Average DC Resistance over all Ball Locations (ohms)	0.0426	0.0419
Pooled Standard Deviation of all Ball Locations (ohms)	0.0143	0.0116

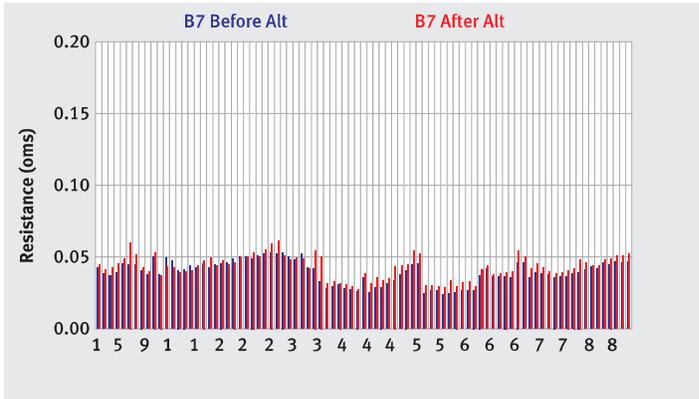
**CHART 4: Triple can average DC resistance before and after ALT.**

DC resistance was measured before and after Accelerated Life Testing. Samples were aged at 85°C / 85% RH (Relative Humidity) for 5 days. **Chart 4** shows the results. The resistance of each sphere is shown as a blue line/ red line pair. The blue line shows resistance prior to ALT and the red line shows resistance after ALT.
